DEPARTMENT OF TRANSPORTATION**DIVISION OF ENGINEERING SERVICES**

Contract #: 04-0120F4Cty: SF/ALA Rte: 80 PM: 13.2/13.9File #: 1.28**WELDING INSPECTION REPORT****Resident Engineer:** Siegenthaler, Peter**Address:** 333 Burma Road**City:** Oakland, CA 94607**Report No:** WIR-021491**Date Inspected:** 04-Mar-2011**Project Name:** SAS Superstructure**OSM Arrival Time:** 700**Prime Contractor:** American Bridge/Fluor Enterprises, a JV**OSM Departure Time:** 1530**Contractor:** American Bridge/Fluor Enterprises, a JV**Location:** Job Site**CWI Name:** John Pagliero and Steve Jensen**CWI Present:** Yes No**Inspected CWI report:** Yes No N/A**Rod Oven in Use:** Yes No N/A**Electrode to specification:** Yes No N/A**Weld Procedures Followed:** Yes No N/A**Qualified Welders:** Yes No N/A**Verified Joint Fit-up:** Yes No N/A**Approved Drawings:** Yes No N/A**Approved WPS:** Yes No N/A**Delayed / Cancelled:** Yes No N/A**Bridge No:** 34-0006**Component:** Orthotropic Box Girder**Summary of Items Observed:**

WELDING INSPECTION REPORT

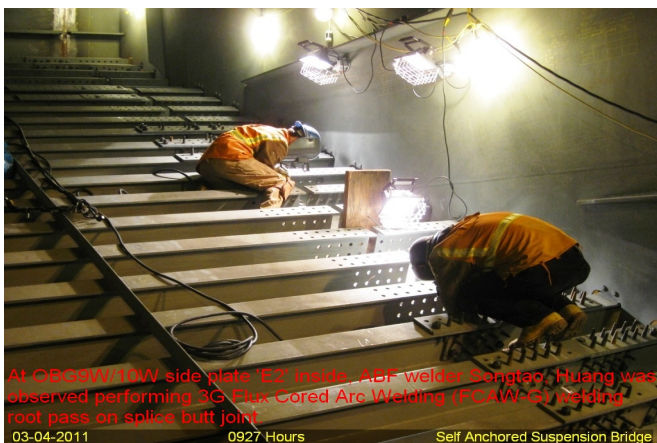
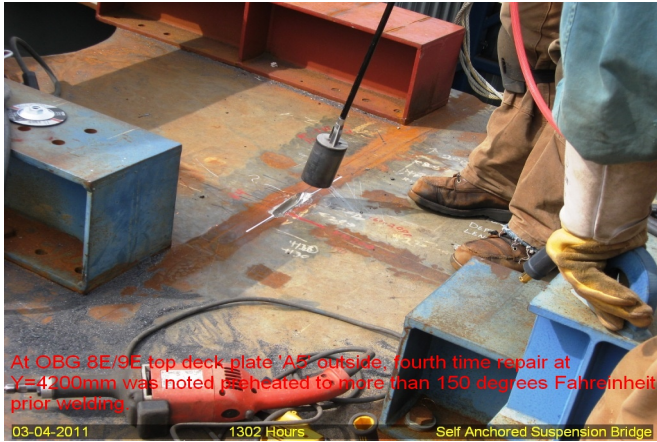
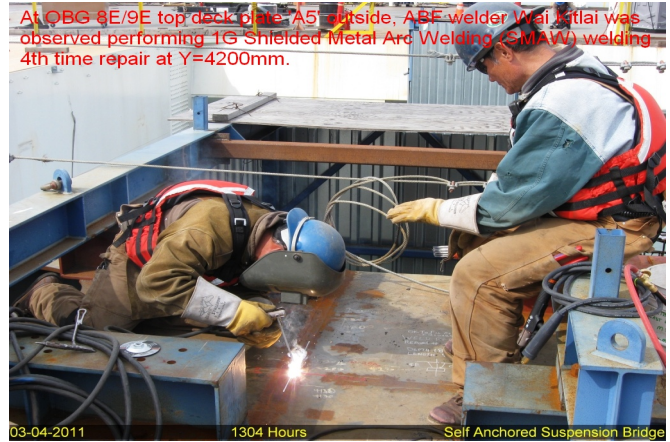
At OBG 9W/10W side plate 'E1' inside, QA randomly observed ABF/JV qualified welder Sungtao, Huang ID # 3794 continuing to perform CJP groove (splice) welding cover pass on the splice butt. The welder was observed perform automatic welding in the 3G (vertical) position utilizing a dual shield Flux Cored Arc Welding (FCAW-G) with E71T-1M, 1/16" diameter wire electrode and implementing Caltrans approved Welding Procedure Specification (WPS) ABF-WPS-D15-3042B-1. The joint being welded has a single V-groove butt joint with backing bar. The splice joint was preheated and maintained to greater than 150 degrees Fahrenheit using Miller Proheat 35 Induction Heating System heater blankets located at the opposite side of the plate prior/during welding. During welding, ABF Quality Control (QC) Steve Jensen was noted monitoring the welding parameters of the welder. During the shift, cover pass welding was completed and the welder has moved to side plate 'E2' of the same OBG and welded the root pass until the ends of the shift.

At OBG 4W/5W LS2 longitudinal stiffener inside, QA randomly observed ABF welder Hua Qiang Hwang ID #2930 perform 3G (vertical) Shielded Metal Arc Welding (SMAW) complete joint penetration (CJP) welding root pass to cover pass on one side of the stiffener splice butt joint. The joint has a double V joint preparation that is being welded from one side using E9018H4R with 1/8" diameter electrode implementing Caltrans approved welding procedure specification (WPS) ABF-WPS-D1.5-1012-3. The joint being welded is a high strength plate material HPS 485W which has a thickness of 30mm was root welded using a ceramic backing. The splice joint

was preheated and maintained to greater than 200 degrees Fahrenheit using Miller Proheat 35 Induction Heating System heater blanket located at the opposite side of the plate prior/during welding. During the shift, cover welding at one side was completed and the welder has moved to the other side. The welder back gouged and ground smooth the other side and after its completion, ABF QC Gary Ersham has performed the Magnetic Particle Testing. The welder continued back welding fill pass on the other side. At the end of the shift, cover pass welding of the stiffener was completed. The QA Inspector noted the ABF QC John Pagliero was on site monitoring the in process preheat and welding parameters. During the shift, QA noted ABF QC was closely monitoring the issuance of E9018H4R electrodes due to its limited exposure time allowed. After the welding completion of the stiffener plates, the welder held and maintained the preheat of 200 degrees Fahrenheit for three hours as required.

At OBG 8E/9E top deck plate 'A5' outside, QA randomly observed ABF/JV qualified welder Wai Kitlai continuing to perform CJP repair welding. The welder was noted welding in 1G (flat) position utilizing SMAW with 5/32" diameter E7018H4R electrode implementing new Caltrans approved Welding Procedure Specification (WPS) ABF-WPS-D15-1003 Repair. The new repair procedure includes putting in place a copper backing alongside the typical steel backing bar when the repair excavation is expected to occur at the edge of the steel backing. The fourth time welding repair located at Y=4200 and having boat shape excavation profile of 150mm long x 30mm wide x 19mm deep was tested with Magnetic Particle Testing (MT) prior welding. During welding, ABF QC John Pagliero was noted monitoring the welder and his welding parameters. QA noted the welder preheating the excavation to more than 150 degrees Fahrenheit prior welding and the parameter during welding was 170 amperes which appears in compliance to the WPS.

At the request of Quality Control Field Supervisor, Bonifacio Daquinag, QA has randomly verified the QC VT/MT of the Complete Joint Penetration (CJP) welding of three longitudinal stiffeners and six lifting lug deck access holes butt joint. The QA verification was performed to verify that the welding and the VT/MT inspection performed by the QC inspector meet the requirements of the contract documents. At the conclusion of the QA verification it appeared that the welds and the QC inspection complied with the contract documents.

1. 8W/9W side plate 'C' inside – QA MT verified
2. 3W-PP22-W3-#1 to #4 lifting lug access holes inside – QA MT verified
3. 5W-PP31-W3-#2 & #4 lifting lug access holes inside – QA VT verified
